# TIRE SERVICE INTERNATIONAL

# **TROUBLESHOOTING & MAINTENANCE GUIDE**

# **EXPANDING HUB & RIM ASSEMBLIES**

# **EXPANDING HUB PREVENTATIVE MAINTENANCE SERVICE BULLETIN**

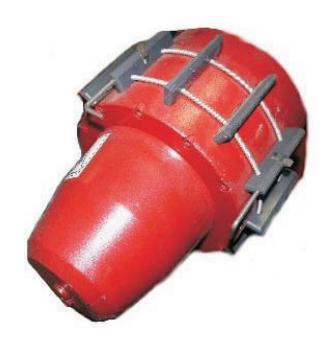
After putting in the springs and paddles the photo below shows what the completed assembly will look like.
